Technical Specification Sheet

Cable for Flame Scanners (Harsh Vibration) - ITS 184X0251M431

Valid from 2018.04.20

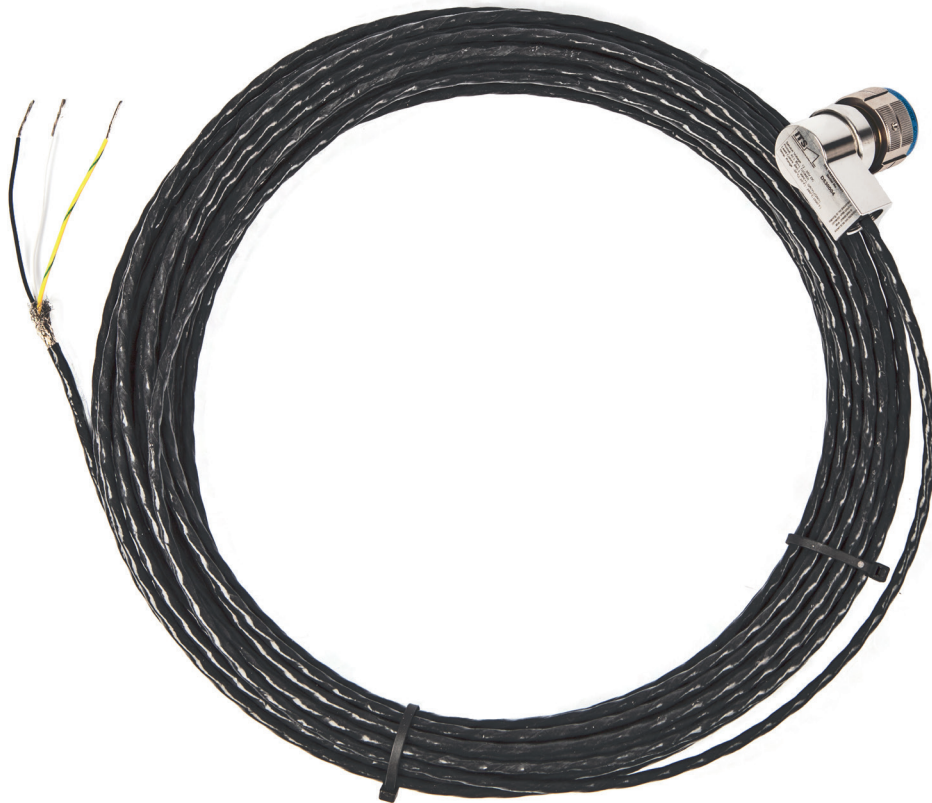
ITS 184X0251M431 Cable for Flame Scanner ITS 184X0254M029

The Flame Scanner Cable, which is used between the Flame Scanner and junction box with a 90° connector made of stainless steel, is a replacement for the OEM's existing version with the rubber covered connector. The used type of connector has been specially developed for high vibration loads.

The used connector ensures optimal linkage between the flame scanner and the protection hose. On the backside of the plug you will find the necessary data and safety instructions imprinted with laser engraving.
